# Manhole Inspection Summary

Manhole # S57M\_\_023MH

Insp Date: **7/2/08 2:01 PM**

**Location** Address: **3901 dillon st**

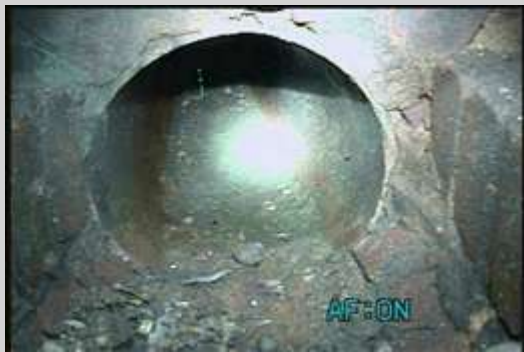
12 O'Clock Outflow

8 in. Circular Gravity Sewer  
Pipe Out @ 12 O'Clock

Pipe Material: **Clay** ☐ Pipe Lined

Invert Depth: **9.72** (ft.) Flow Characteristics: **None**

Deposits: ☒ None ☐ Mud ☐ Sludge ☐ Debris ☐ Grease

Infiltration: **None** Pipe Seal Cond: **Unknown**

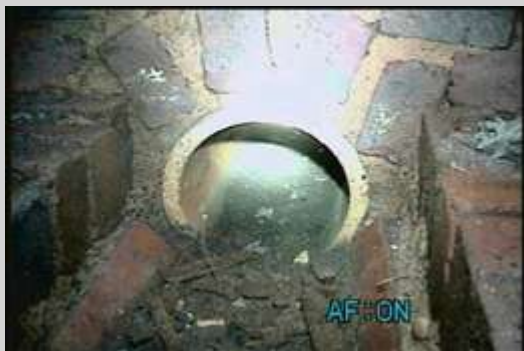
6 O'Clock Inflow

6 in. Circular Gravity Sewer  
Pipe In @ 6 O'Clock

Pipe Material: **Clay** ☐ Pipe Lined

Infiltration: **None** Pipe Seal Cond: **Unknown**
